# Steering Wheel Quick Release

**There have been a number of incidents involving 5 Speeder steering wheels inadvertently becoming detached.**

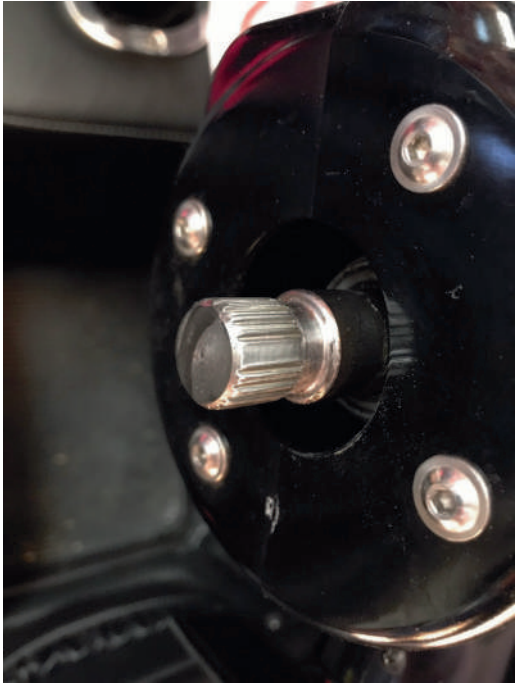
*Steering column, wheel removed*

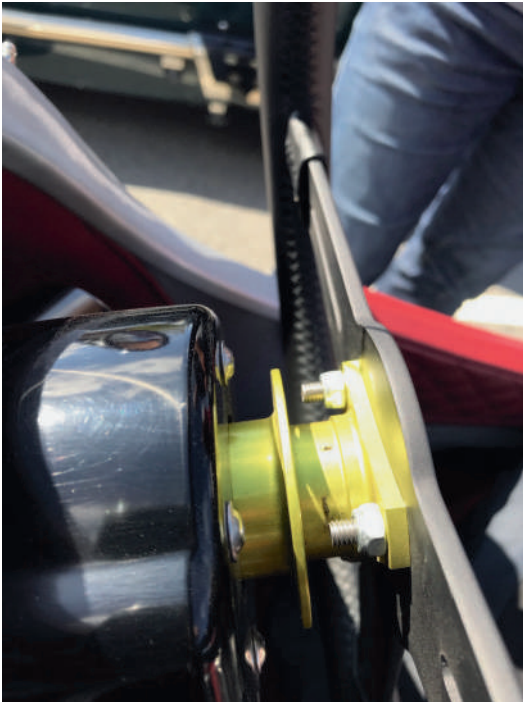
*Traven quick-release assembly*

The Traven QR has finer splines than the earlier Lifeline item; these splines seem to be poorly formed when examined closely. There is a wider master spline on both types of QR but the Traven one can be misaligned yet still allow the steering wheel to be partially fitted/wedged into place. Thus to the unwary the steering wheel can appear to be locked into position, when it isn't.

The Traven QR is fitted to 5 Speeders built after April 2017.

in and out of the car they do not need to remove the steering wheel. Therefore, I would advise all 5 Speeder owners to disable the steering wheel quick release unit, no matter what type is fitted. This can be easily achieved by fitting an additional nut on a wheel-to-QR retaining bolt. This will prevent the release collar moving fully and not allow the wheel to be removed. The benefits are that it will prevent anyone tampering with the steering wheel when you are not with the car, theft of the wheel or inadvertent operation of the QR. It is easily reversible for maintenance access.

If you have a car with a Traven QR, check that it is correctly fitted by removing and refitting the steering wheel. It should come off and refit without having to force it, sliding over the master spline and fully locking in place with the release collar clicking into place. Once you have established it is correctly fitted, put the extra nut on one of the wheel fixing bolts and leave it in place.
